**North Fork Watershed Project**  
**2010 Brook Trout Habitat Study**

**9 September 2010**

**Evan Supak and Athey Lutz**  
**North Fork Watershed Project**  
**[brooktrout@northforkwatershed.org](mailto:brooktrout@northforkwatershed.org)**

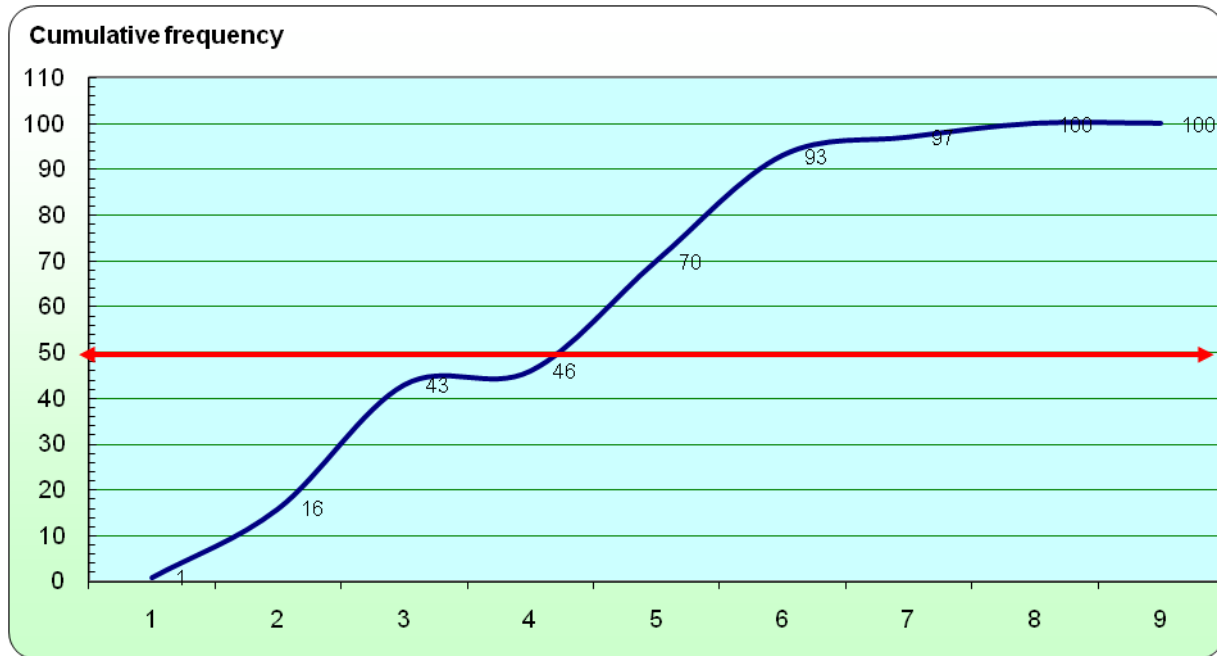
### Big Run Pebble Count Data

Size class	Size range	Point values	Pebble count data		Reach %	Cumulative frequency	
			Count	Score			
Silt/clay	< .062	0.0	1	0	1	1	
Sand	.062 - 2	1.0	15	15	15	16	
Fine gravel	3 - 24	2.0	27	54	27	43	
Coarse gravel	25 - 64	3.0	3	9	3	46	
Cobble	65 - 255	4.0	24	96	24	70	
Boulder	256 - 2048	5.0	23	115	23	93	
Bedrock		6.0	4	24	4	97	
Woody debris	Not included in the index calculations		3		3	100	
Artificial materials					0	100	
<a href="mailto:timothy.d.craddock@wv.gov">timothy.d.craddock@wv.gov</a>			Totals	100	313	100	% Fines
			Index	3.13		100	16

- (1) Silt/clay      (2) Sand      (3) Fine gravel      (4) Coarse gravel      (5) Cobble      (6) Boulder      (7) Bedrock

at our sample site. Channel width at our sample site was 5 feet, with an average depth of 0.48 feet. The pebble count for Big Run was conducted by the measurement of 100 pebbles along the streambed and was found to have an index of 3.13. Silt/Clay substrate (<.062 mm) was found in only 1% of the study reach. Sand substrate (.062 mm-2 mm) was found in 15% of the study reach. Fine gravel substrate (3 mm-24 mm) was found in 27% of the study reach. Coarse gravel substrate (25 mm-64 mm) was found in 3 % of the study reach. Cobble substrate (65 mm-255 mm) was found in 24% of the study reach. Boulder substrate (256 mm-2048 mm) was found in 23% of the study reach. Bedrock substrate was found in 4% of the study reach. Woody debris was found in 3% of the study reach. Complete pebble count data can be found in appendix B of this document. Three macroinvertebrate samples were taken on Big Run and composited into one master sample. 14 different taxa were present in our sample, 8 of which represented the Ephemeroptera, Plecoptera, or Trichoptera (EPT) orders. Mayflies (*Ephemeroptera*), stoneflies (*Plecoptera*), net-spinning caddisflies (*Trichoptera*), dragonflies (*Anisoptera*), riffle beetles (*Elmidae*), black flies (*Simuliidae*), crane flies (*Tipulidae*), crayfish (*Decapoda*), and aquatic worms (*Oligochaeta*) were all present in the Big Run macroinvertebrate sample. The biotic index for Big Run was 4.72. The total taxa score, EPT taxa score, and biotic index were compiled to achieve a stream integrity score of 21, a suboptimal integrity rating. Complete macroinvertebrate data for each stream can be found in appendix C of this document.
